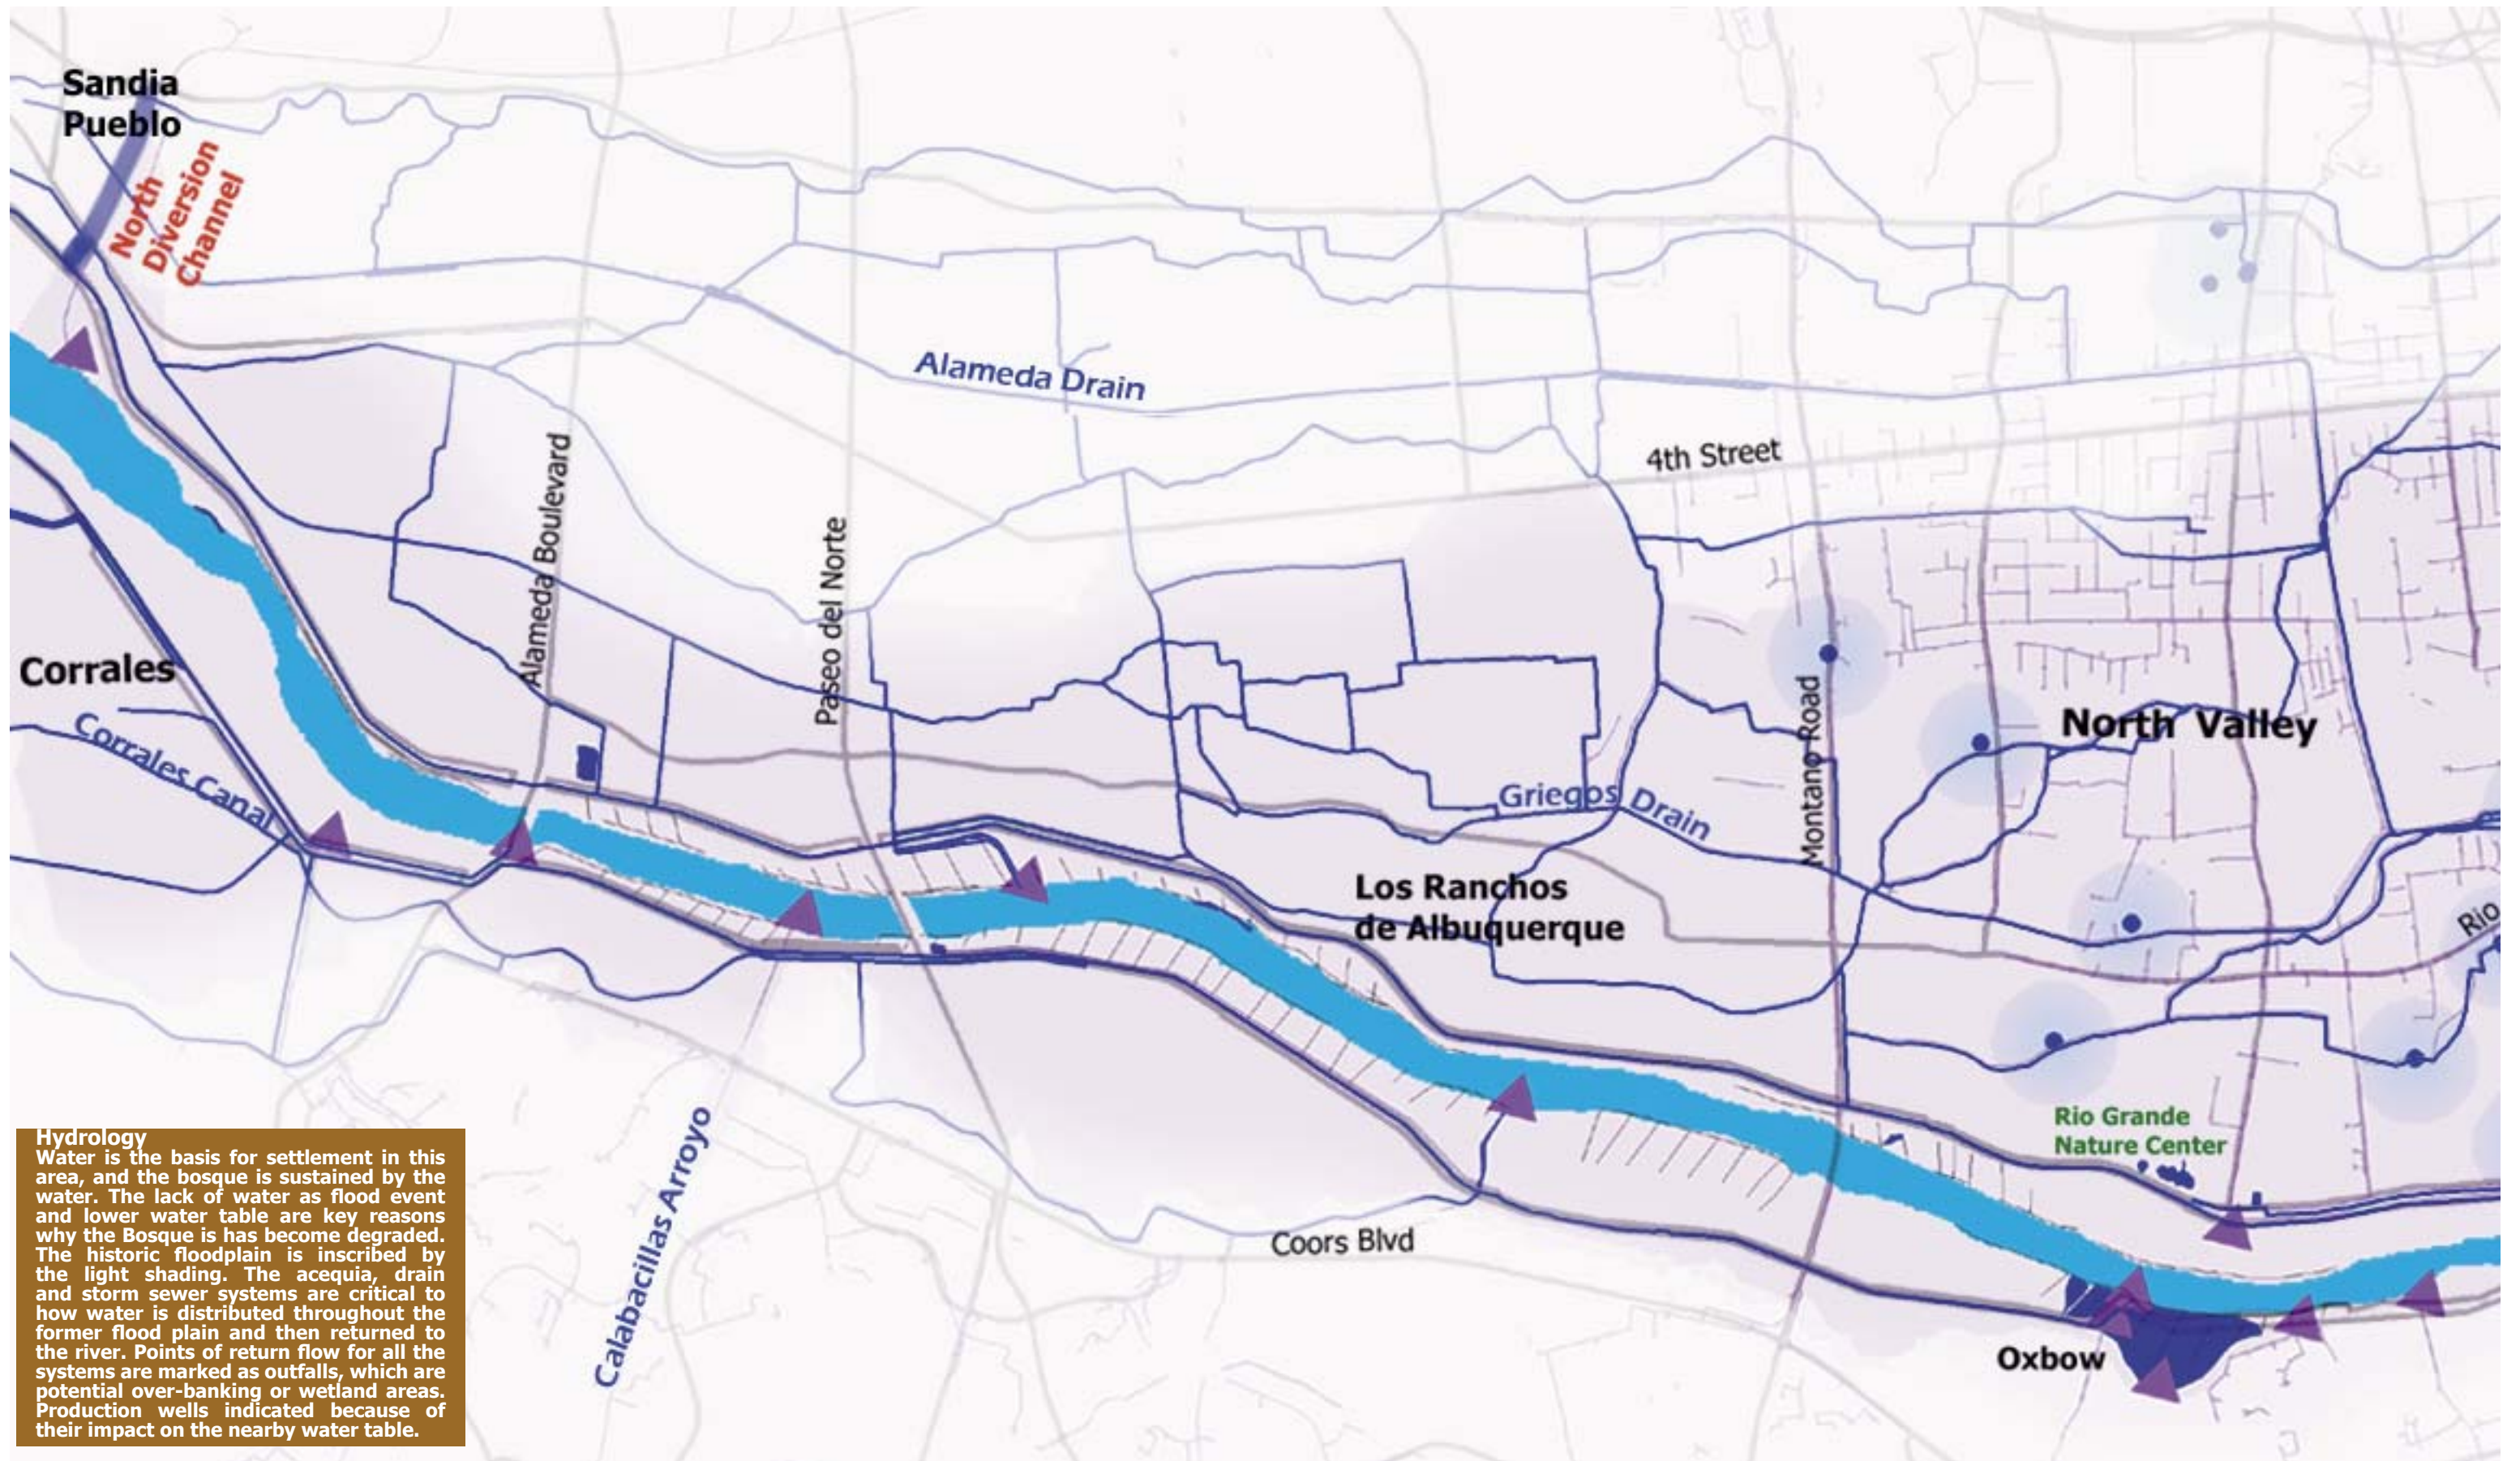
Hydrology
 Water is the basis for settlement in this area, and the bosque is sustained by the water. The lack of water as flood event and lower water table are key reasons why the Bosque is has become degraded. The historic floodplain is inscribed by the light shading. The acequia, drain and storm sewer systems are critical to how water is distributed throughout the former flood plain and then returned to the river. Points of return flow for all the systems are marked as outfalls, which are potential over-banking or wetland areas. Production wells indicated because of their impact on the nearby water table.
